## International Harvester (Eaton style) FA-50 Front Axle Repair

Last Revision 2020-11-12

The following photos and narrative show the re-assembly process for the outer ends of an IHC FA-50 axle. This axle has some similarities to the front driving axles used in the WWII-vintage M-series trucks and was used from 1953-1961 in the IH 140 & 160 4x4 trucks. The axle shown in this example is in a 1956 S-140 4x4 (see final pictures in narrative).

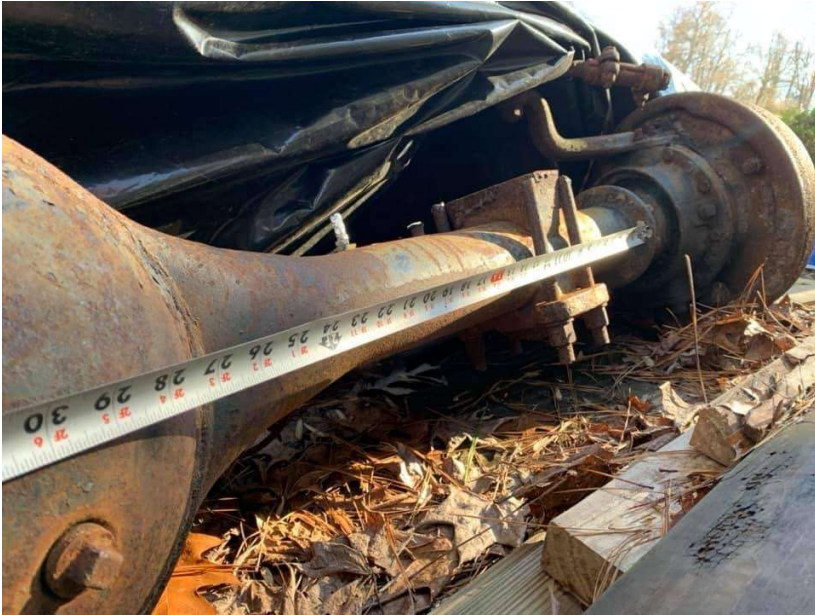
This pic (below) shows you where I'm starting the measurement, the inside of the flange on the long side of the axle. (This is a narrow axle.)

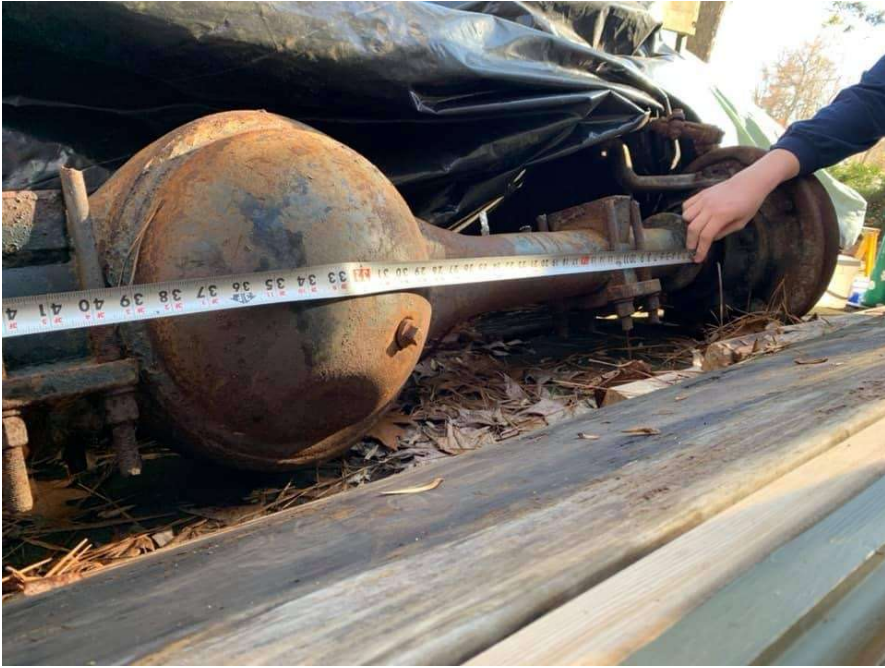
This photo (below) shows the over the hump measurement.

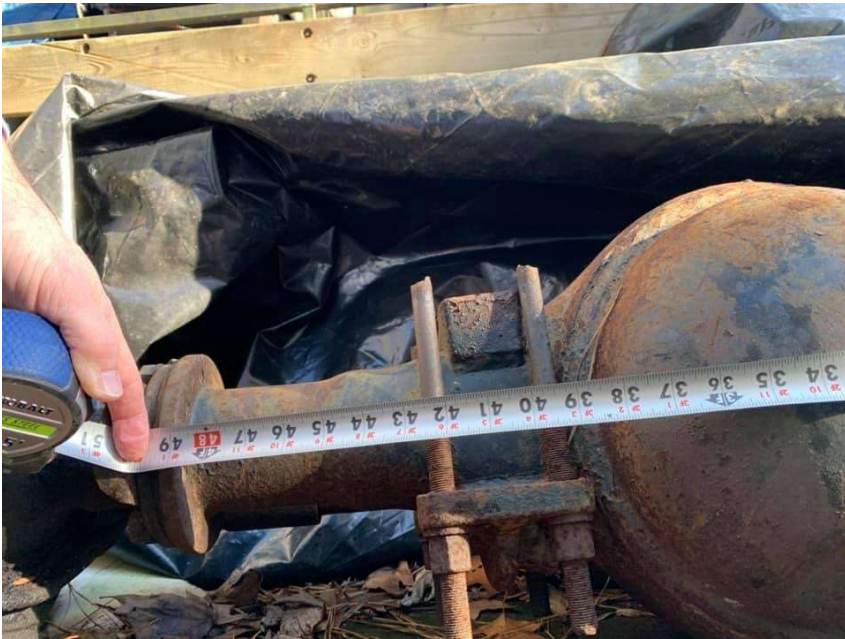
This photo (below) is the measurement on the narrow R/S axle. Sorry for the bad angle. Width is approximately 48.75 inches.

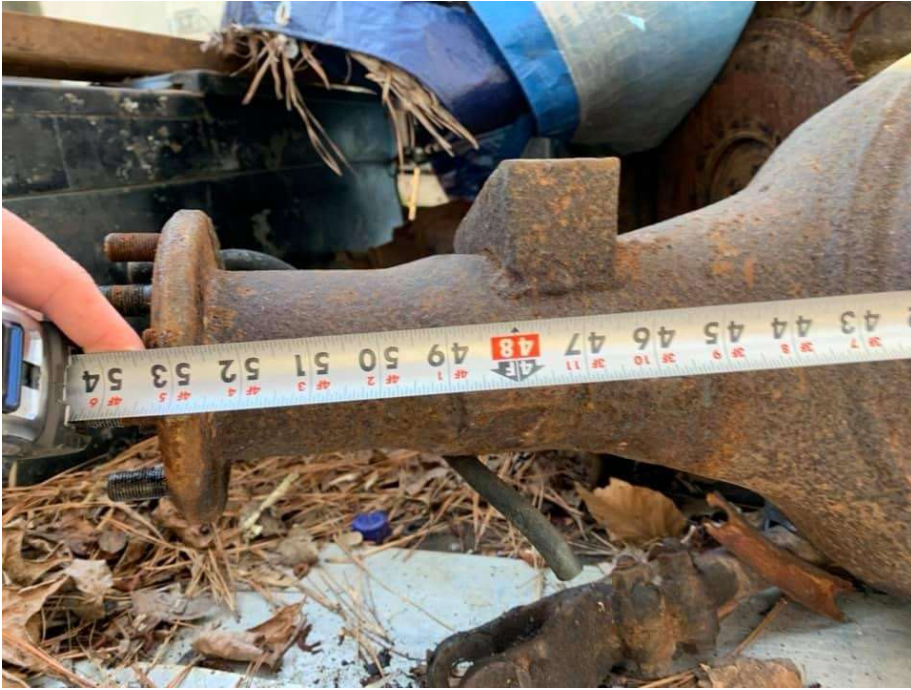
This photo (below) is the same measurement on the wide A/B axle. Again, bad angle, but close enough for what we're doing. Width is approximately 52.75 inches.

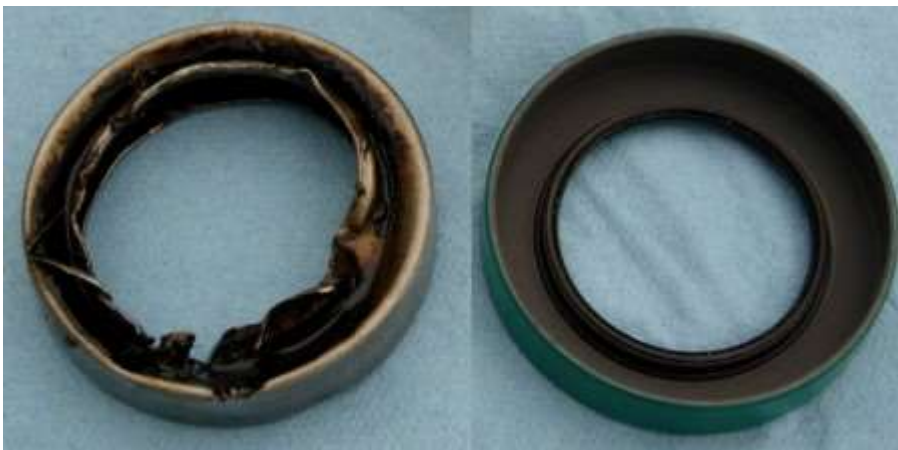
On the left is the remains of the original IHC axle seal (108294H) which was damaged on removal. The sealing surface, now missing, was made of rawhide leather.

On the right is the replacement seal (C-R 16816) which has a nitrile sealing surface.

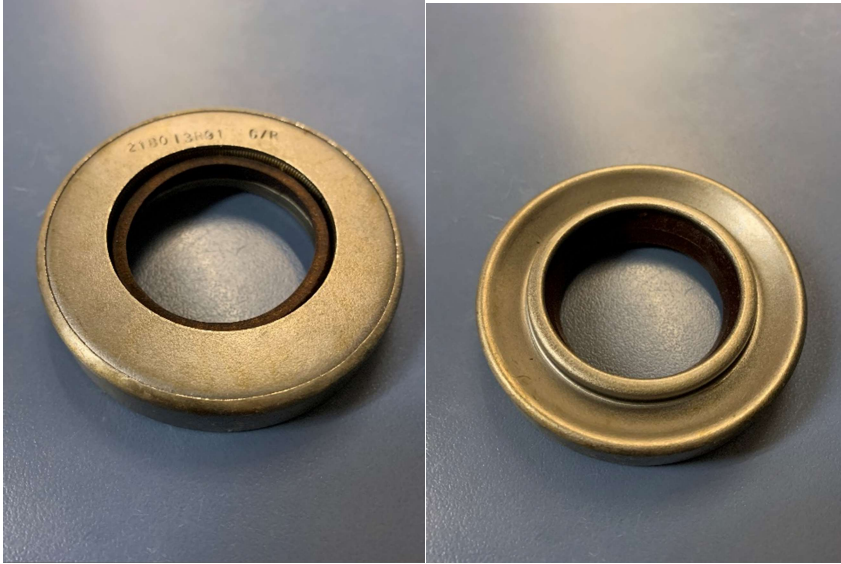
These are pics of the original leather seal (218013R91). I have not located a modern replacement, but will. The dimensions are in the grid above.

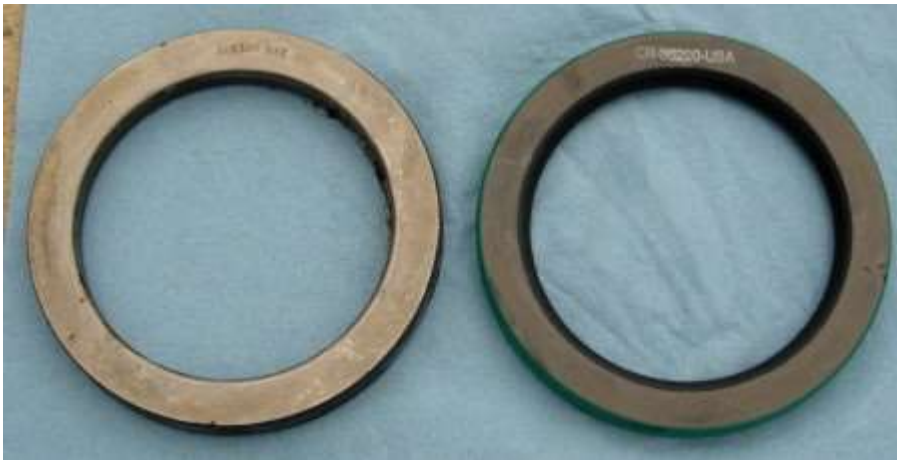
The seal on the left is the original IHC 108320HAX hub grease seal. A call to the Chicago Rawhide tech support line revealed that it is listed in their database as obsolete - not available.

Fortunately there's an even better modern alternative, shown on the right. It's C-R 36220. Thanks to [BinderPlanet](#) member **Geoff** who did the research to find this modern replacement!

These seals each take a different approach to sealing the hub. The original has a sealing surface on the **outer** edge, while the new replacement has a sealing surface in the **inner** edge. The following pictures will show how each works.

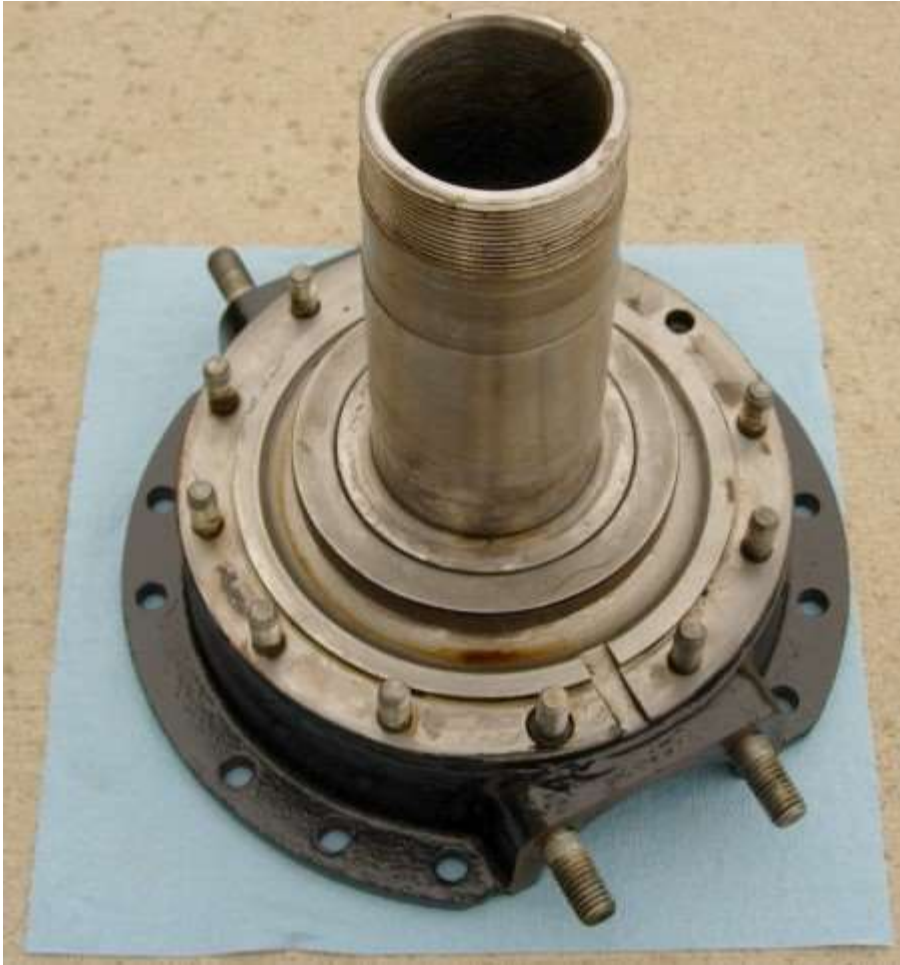
The original 108320HAX seal is pressed on to the base of the spindle, as shown on the left. The seal is in a fixed position.

This seal consists of a felt ring held in a circular steel stamping. When new, the felt extends slightly beyond the outer edge of the stamping to come into contact with the spinning hub.

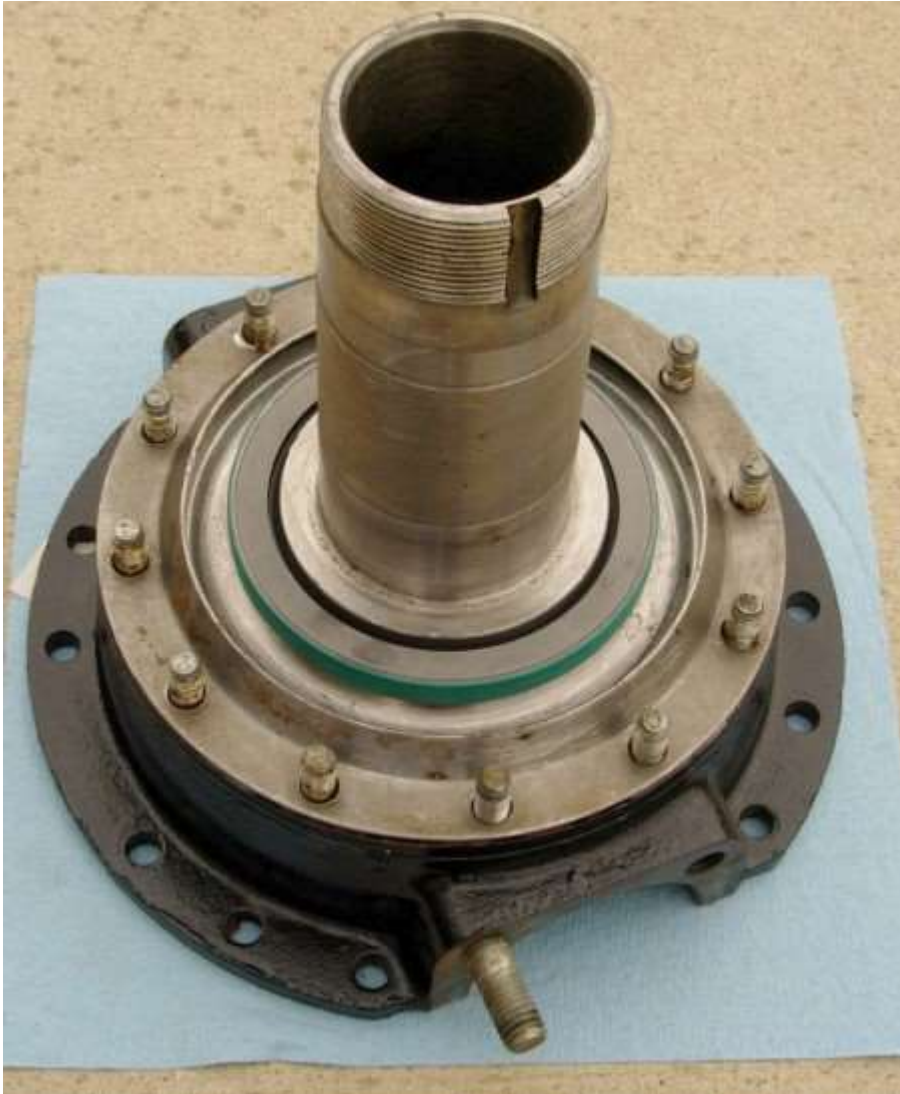
This picture shows the new replacement 36220 in place on the wheel spindle **for test / photo purposes only**. During final assembly it will actually be pressed into the wheel hub. It will be in a fixed position in the hub and will spin around the axis of the spindle, instead of the original, opposite approach. The nitrile surface is on the **inner** edge.

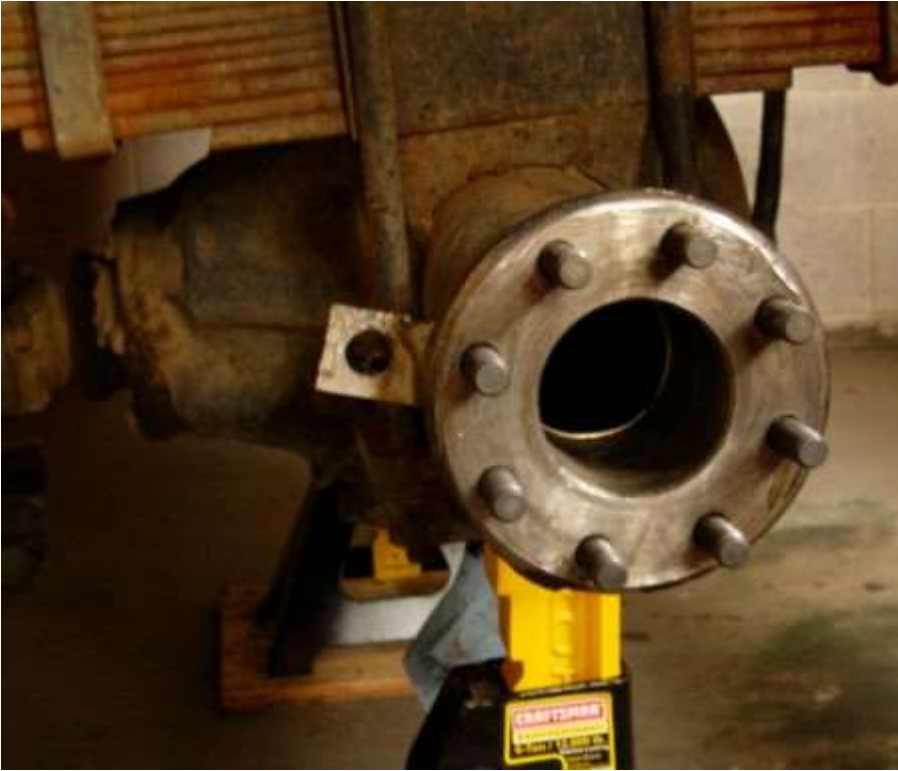
This photo shows the open end of the FA-50 axle tube (passenger side) with all components from the trunnion yoke and outward removed.

A slight ridge is visible down the inside of the axle tube, about 3.5" from the end. This is the stop for the axle seal. This axle seal has already been removed using a slide hammer with a hook attachment.

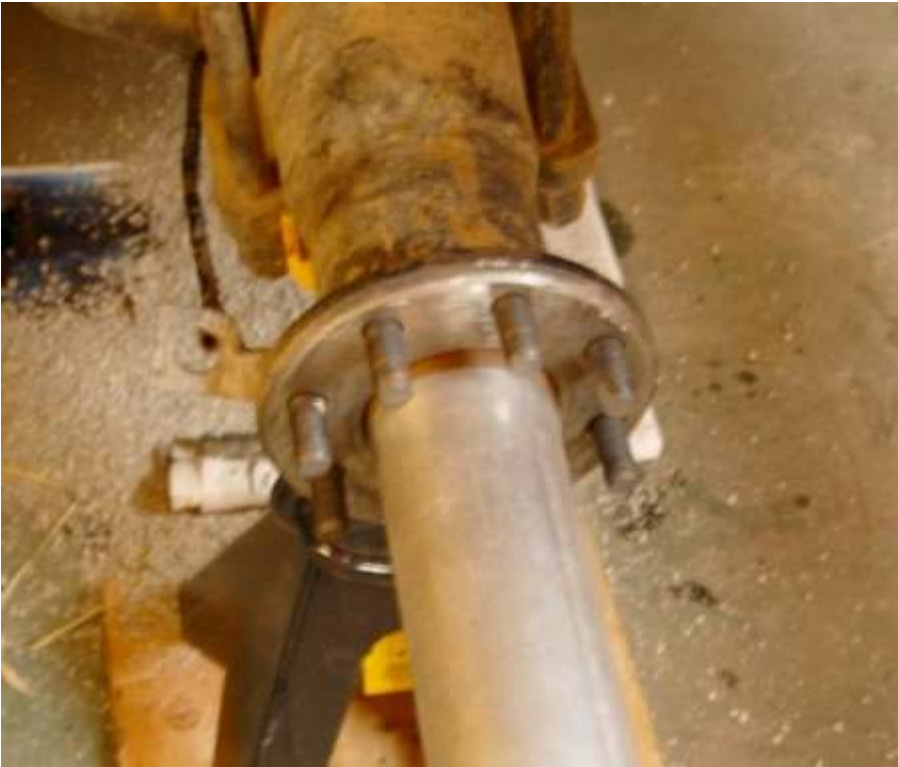
A short section of 2.5" exhaust pipe with an expanded end turned out to be a perfect tool for driving in the axle seal. It stayed perfectly square in the bore and made contact with the outer edge of the seal.

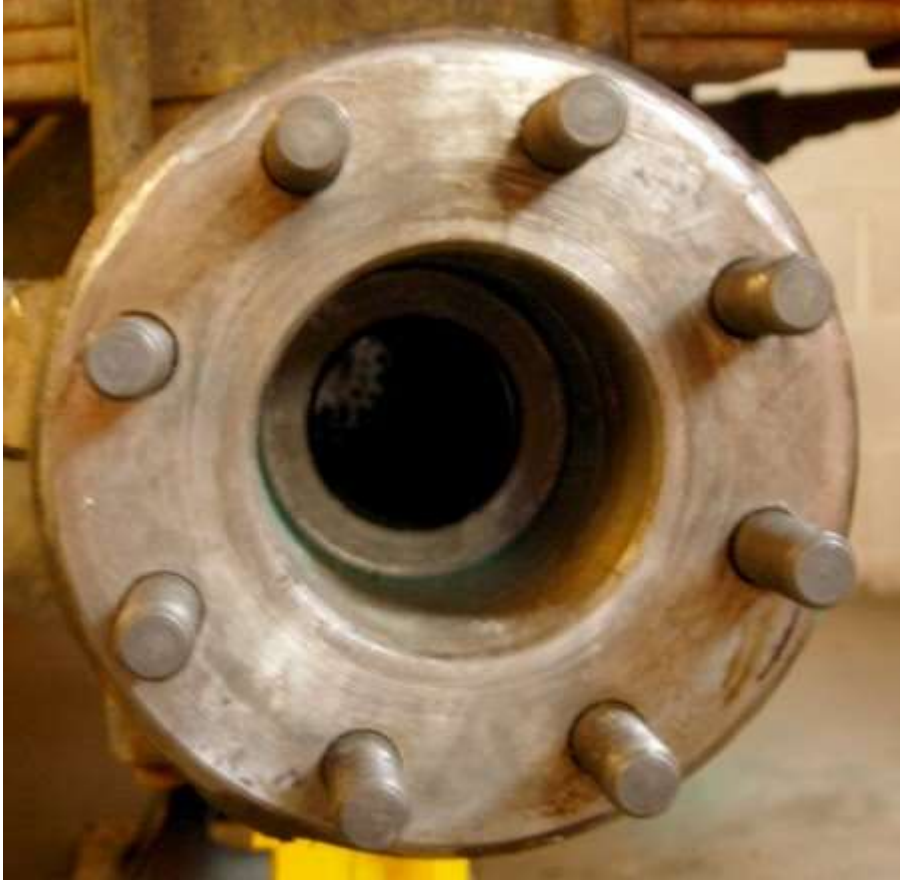
The new axle seal in position. I used a dental inspection mirror and a flashlight to ensure the seal was pressed in to the stop ridge.

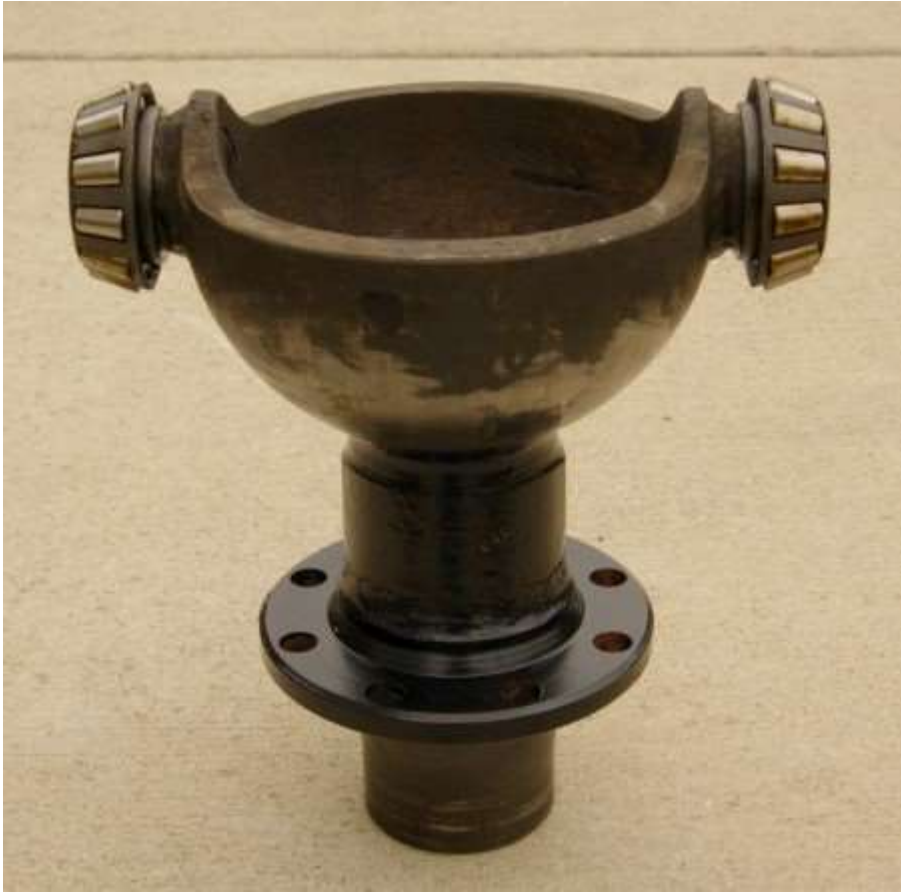
Here's a shot of the trunnion yoke, prior to assembly.

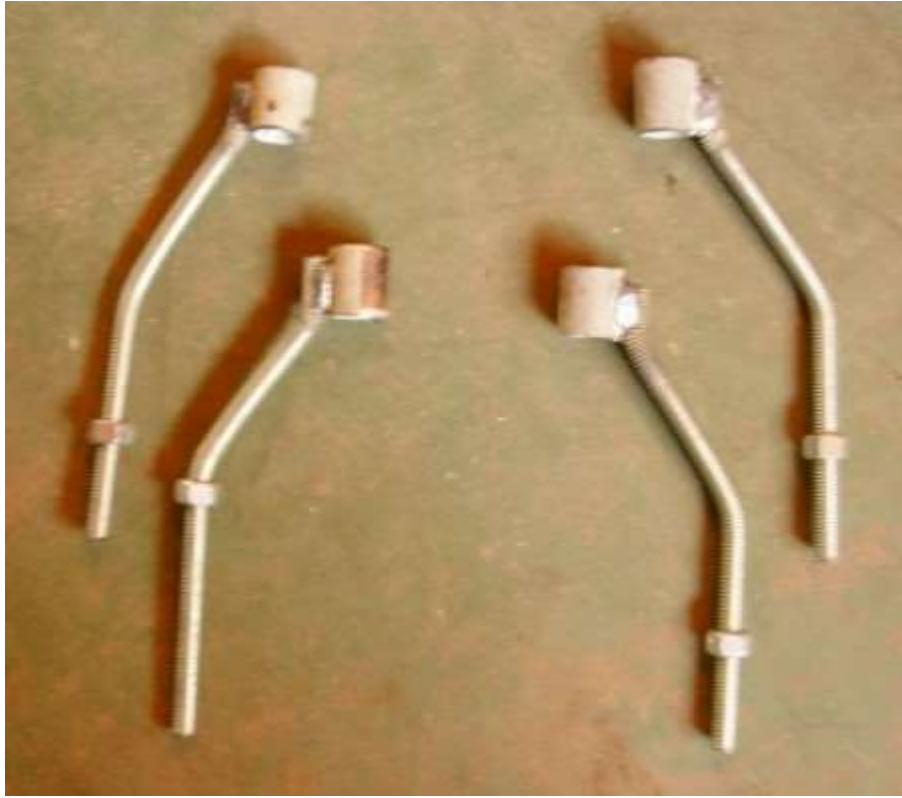
I made a set of installation brackets that I call "spiderlegs" using some .375" threaded rod and some scraps of .5" water pipe welded together.

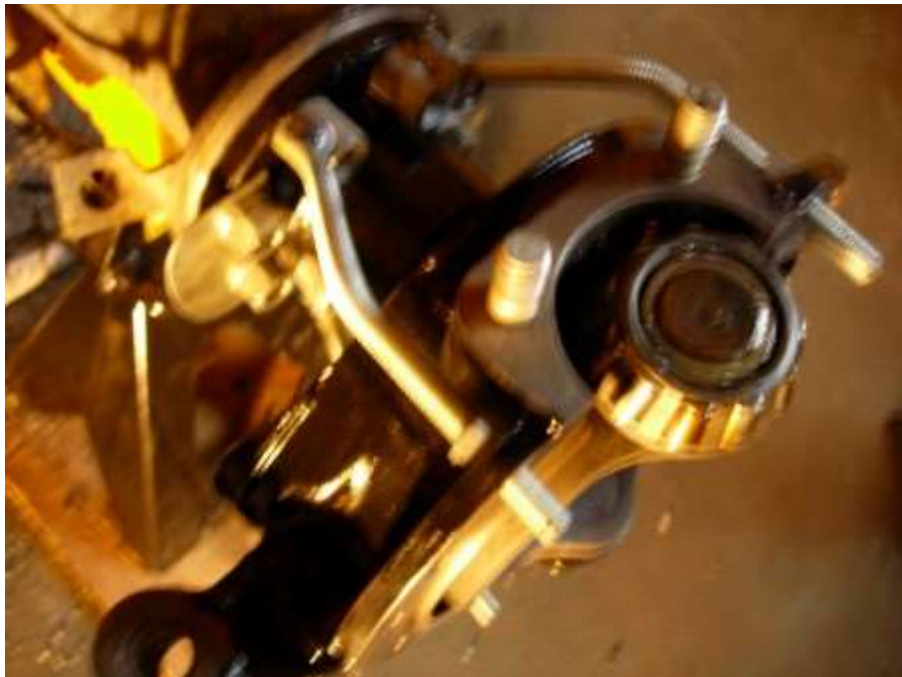
The rear half of the knuckle case has been put in place around the trunnion yoke, and the yoke has been installed on the axle tube and held on with 4 of the 8 nuts.

The spiderlegs are used to hold the rear of the knuckle case against the bell of the trunnion yoke. The nuts are just finger tight, or less, which keeps the case against the bell. The tubes of the spiderlegs fit around the 2 top and 2 bottom studs which do not have nuts on yet.

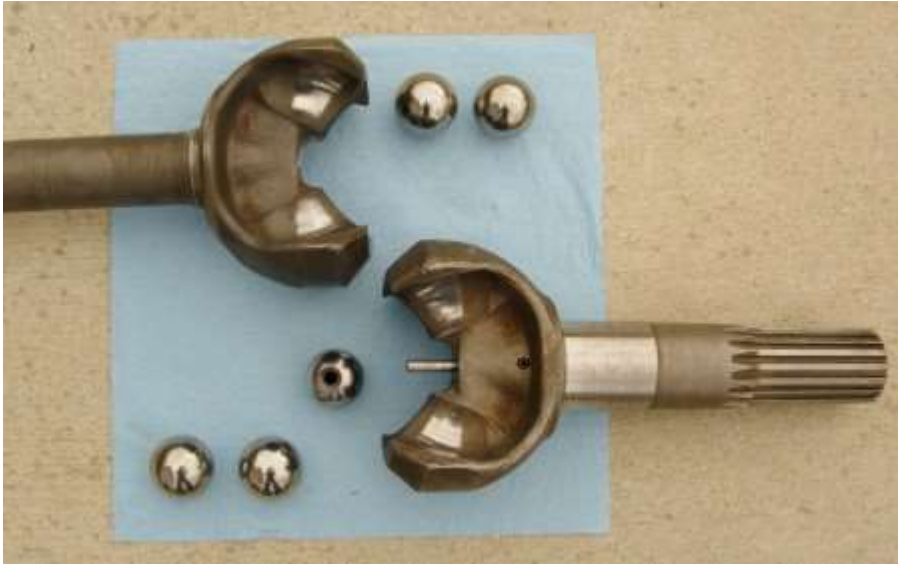
Here are the components of the axle / CV joint assembly. The axle shaft (upper left) and drive shaft (lower right) are shown with 4 drive balls and one retaining ball. Note that the retaining ball has a hole down the center. This ball is placed on the pin protruding from the drive shaft.

Note also the small hole drilled crossways in the middle of the drive shaft. This hole contains a roll pin that serves as a stop for the retaining pin.

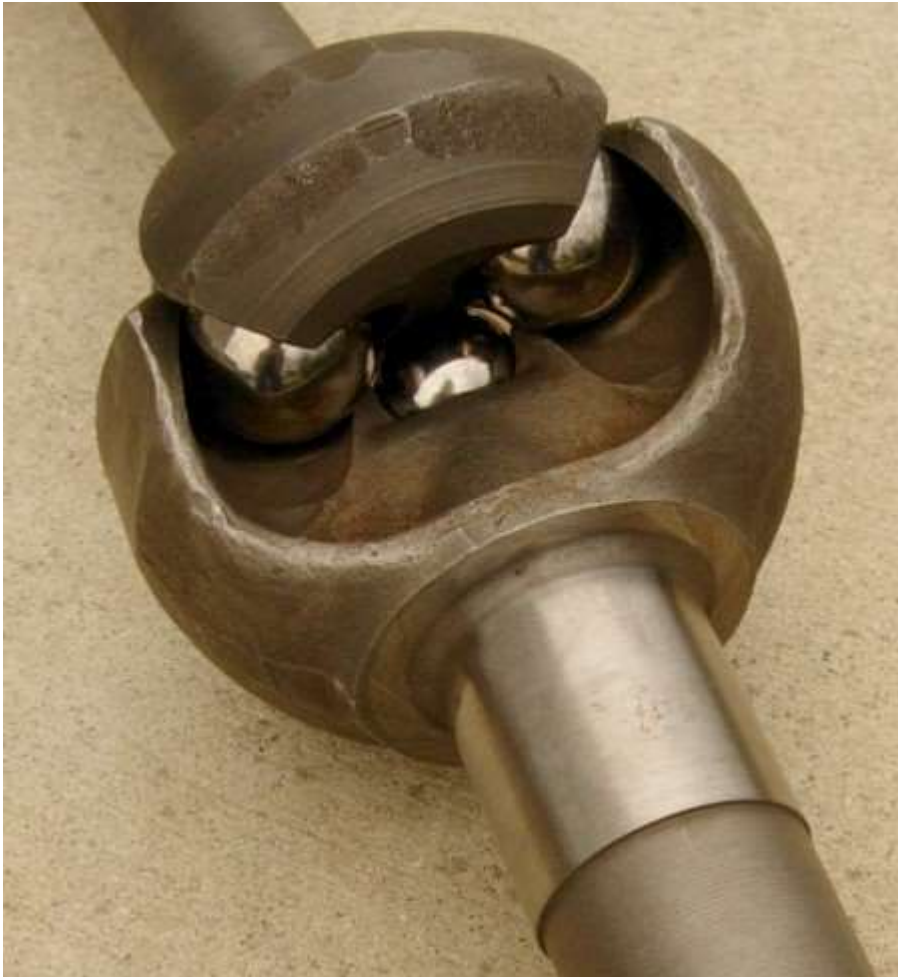
Here's a closeup view of the assembled CV joint.

The IH manual calls for a convoluted assembly process that involves removing the roll pin and retaining pin and moving the retaining ball around. However, during disassembly the whole CV came apart on me inadvertently when the drive shaft was manipulated at an extreme angle, so I knew it had to go back the same way. It did, after a little trial and error.

Don't force it - you don't want to bugger up the drive balls. There's one particular angle when that last ball falls right into place.

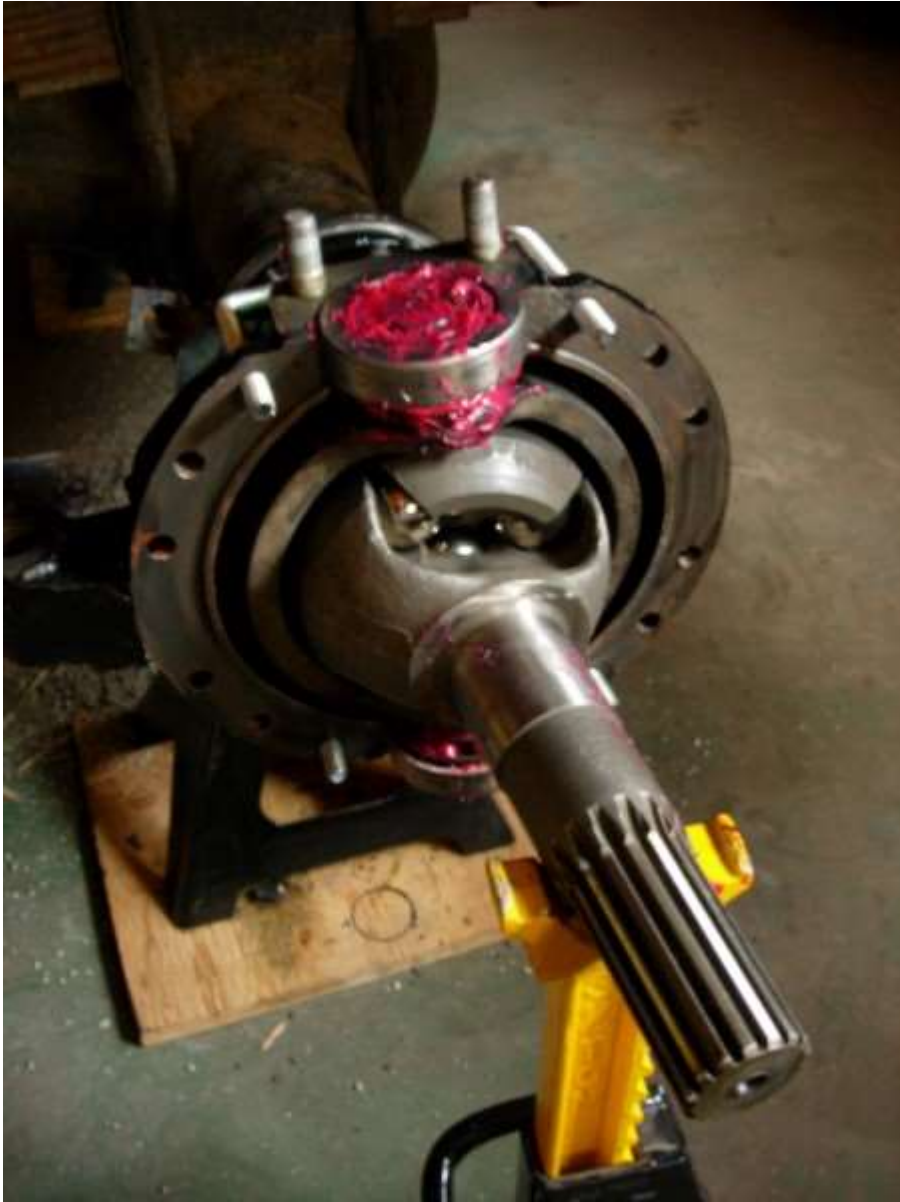
The upper and lower trunnion bearings have been lubed with Mobil 1 synthetic grease and the races have been set in position.

Note the spiderlegs are holding the knuckle case half snugly in position, which also helps keep the races in place. The ends of the spiderlegs will also serve as alignment pins when the outward half of the knuckle case is set in position.

The axle assembly was lubed at the appropriate places with M1 grease and installed in the axle tube. The voids within the CV joint will be also filled with M1 grease before the outer case half is installed.

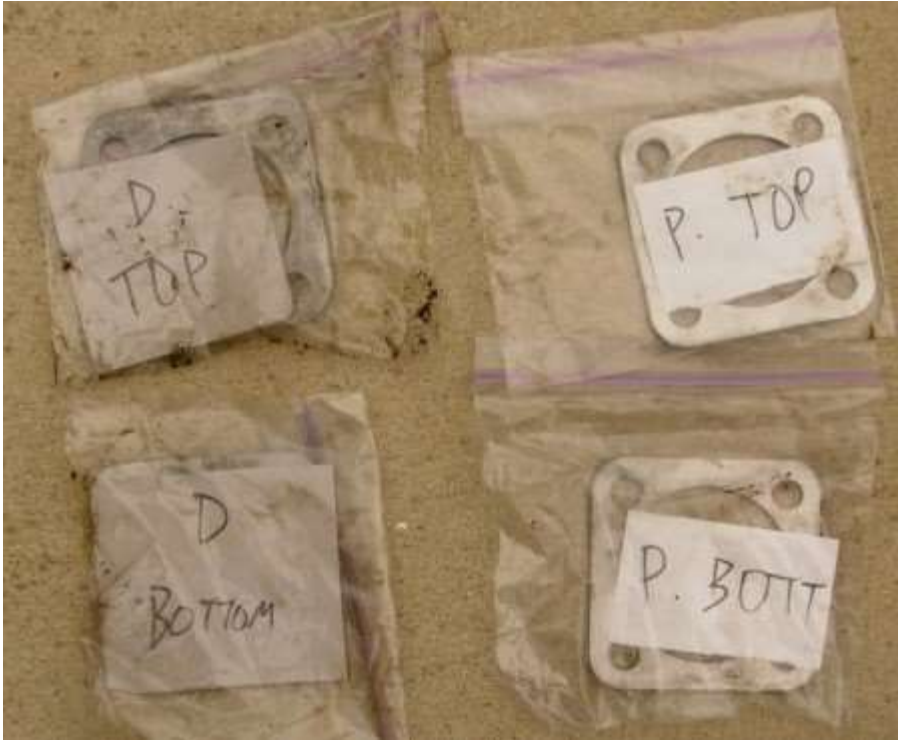
The preload on the upper and lower trunnion bearings is set with shims between the knuckle case and the bearing cover plates. It's important to keep the shims together in their respective sets, and install them in the original positions.

I originally placed each set of shims in a ziploc bag along with a tag noting their location.

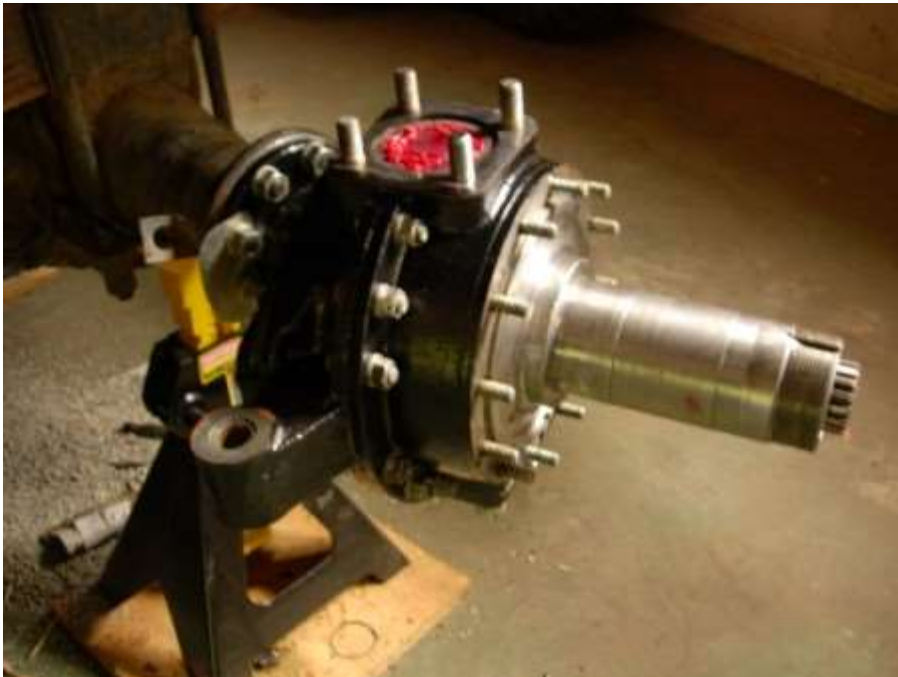
This shows the outer knuckle case half installed. A set of shims from the previous picture have been set in place around the opening at the top.

After the outer knuckle case was set in place and 4 of the thru-bolts were finger-tightened, the nuts on the spiderlegs were backed off and they were removed.

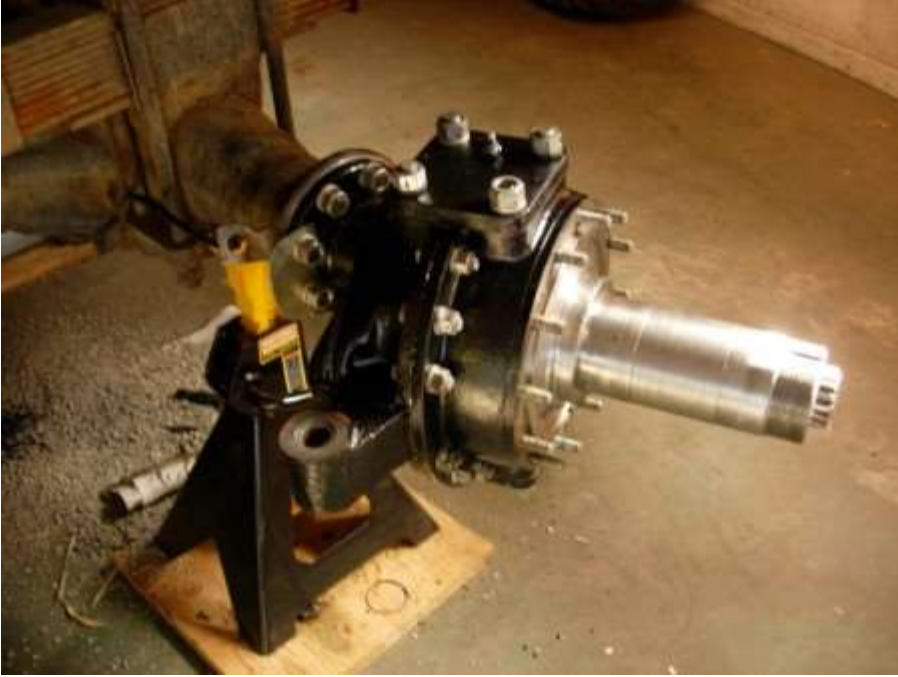
The square bearing cover plate has been installed over the shims and the 4 retaining nuts have been tightened down on the studs.

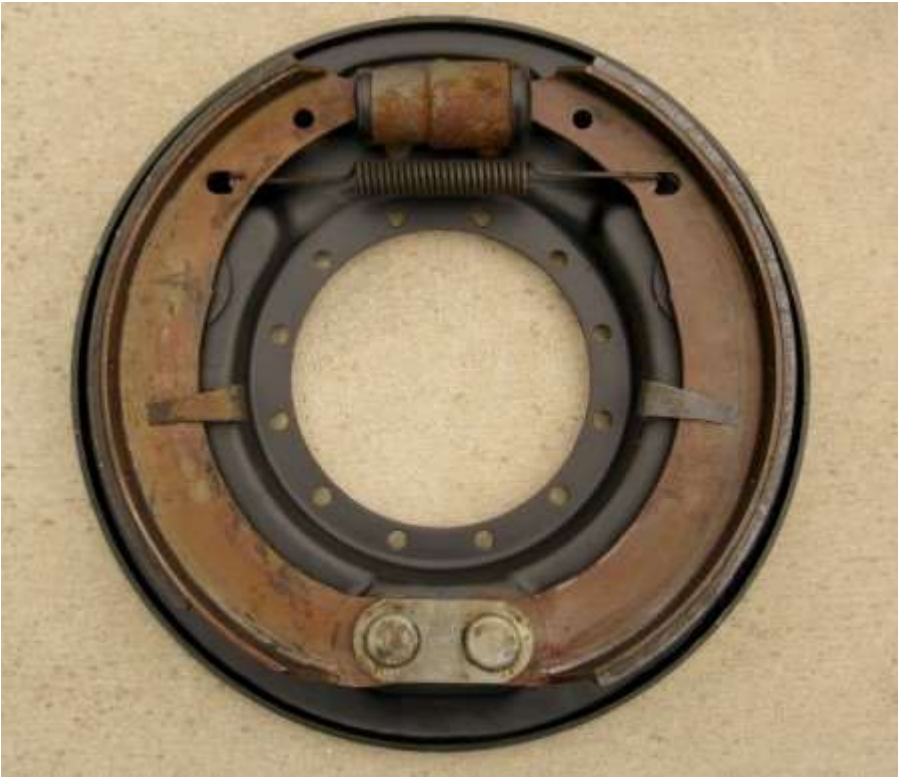
Here's the passenger side brake assembly. According to the IH shop manual the shoe with the longer lining is considered the primary and is mounted on the forward side of the assembly. The shoe with the short lining is considered the secondary

The large side of the stepped wheel cylinder is toward the forward, or primary shoe.

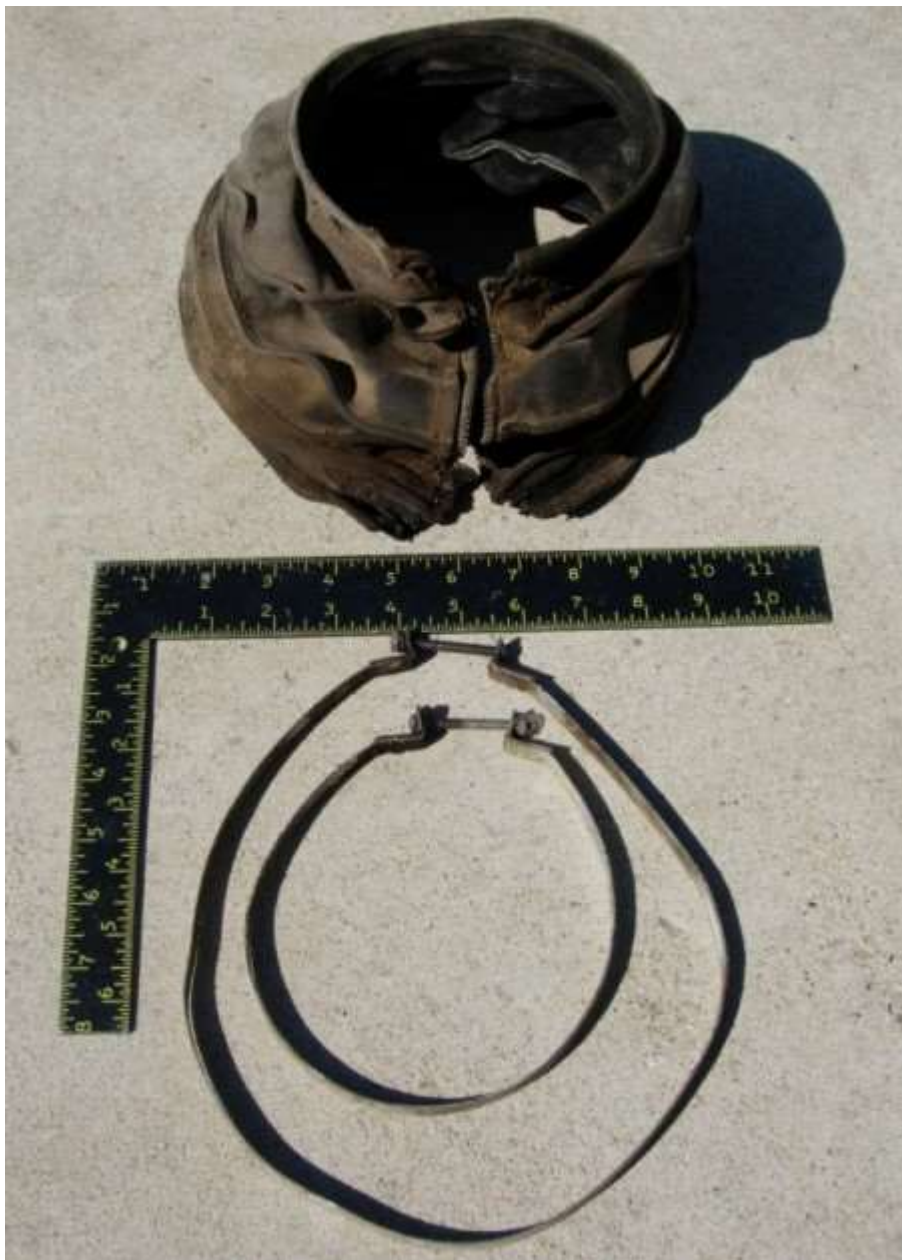
At the left is the original **leather** axle boot and clamps. Note the zipper down the bottom edge (facing side) that allows the boot to be removed.

This boot has a broken zipper and a number of tears in the leather.

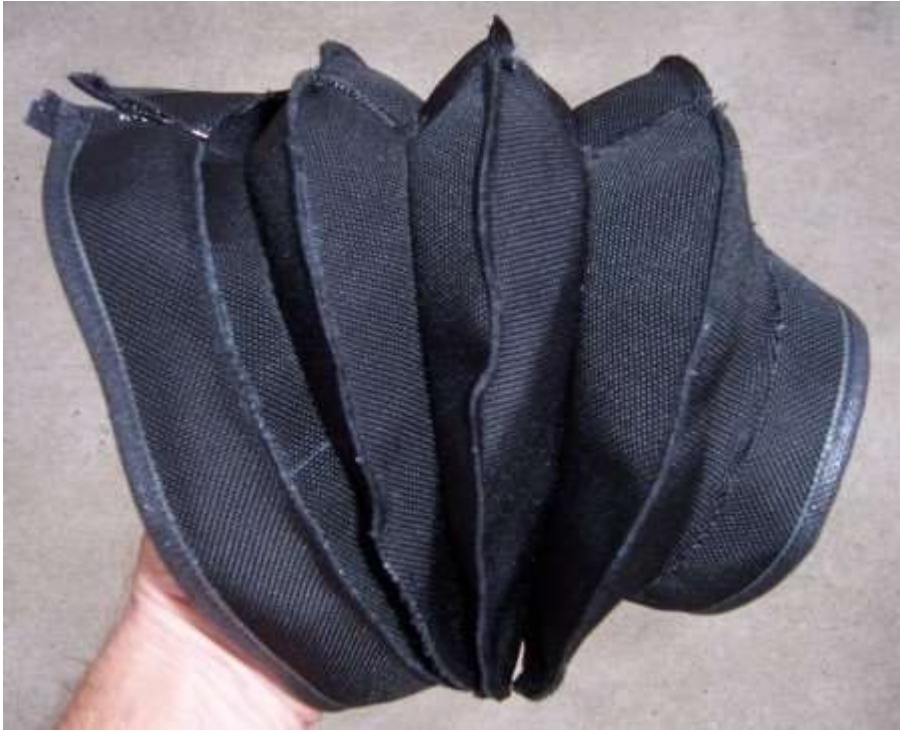
I am a big fan of Cordura, having a set of hunting boots that I've been abusing for years with virtually no maintenance. I decided to make the replacement boots from 1050-Dernier Ballistic Cordura.

I made an initial attempt to sew these myself, and although my wife's sewing machine is a very nice model, it simply wasn't up to the task of sewing this tough material.

Fortunately, I have a friend with a commercial sewing business who was kind enough to sew these with a commercial-grade machine. The new boots came out quite nicely, as the picture shows. Note the zipper along the top of the boot.

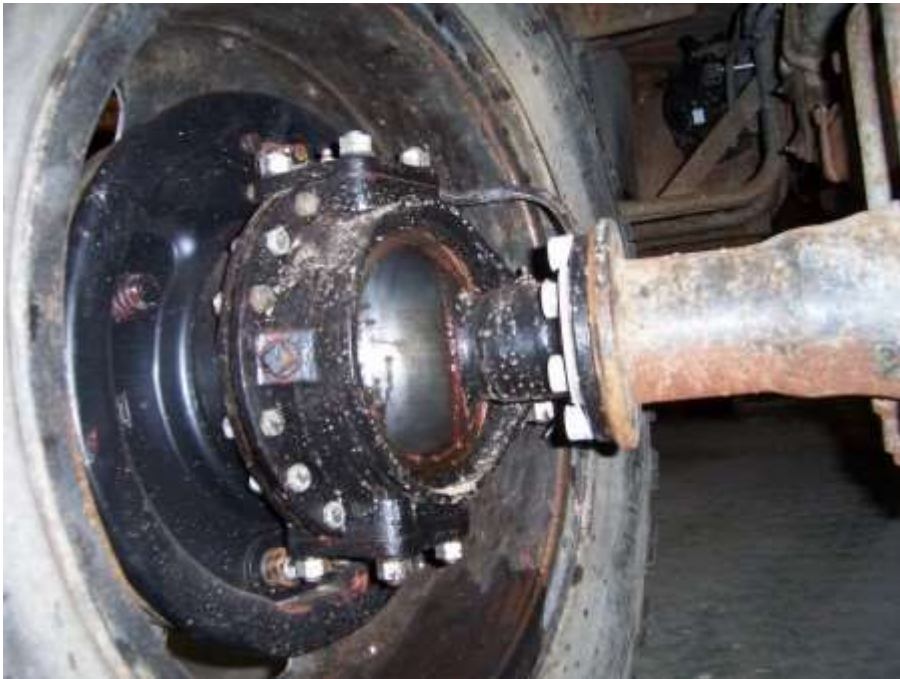
Here's a picture of the hub and trunnion yoke. The new boots will cover the exposed "bell" of the trunnion yoke.

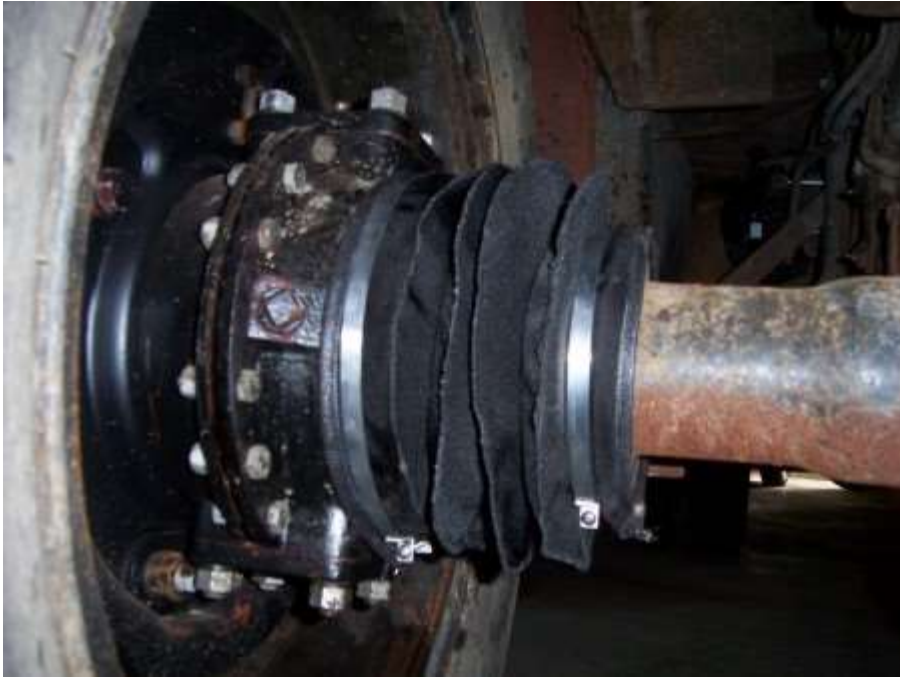
This picture shows the new boot, installed.

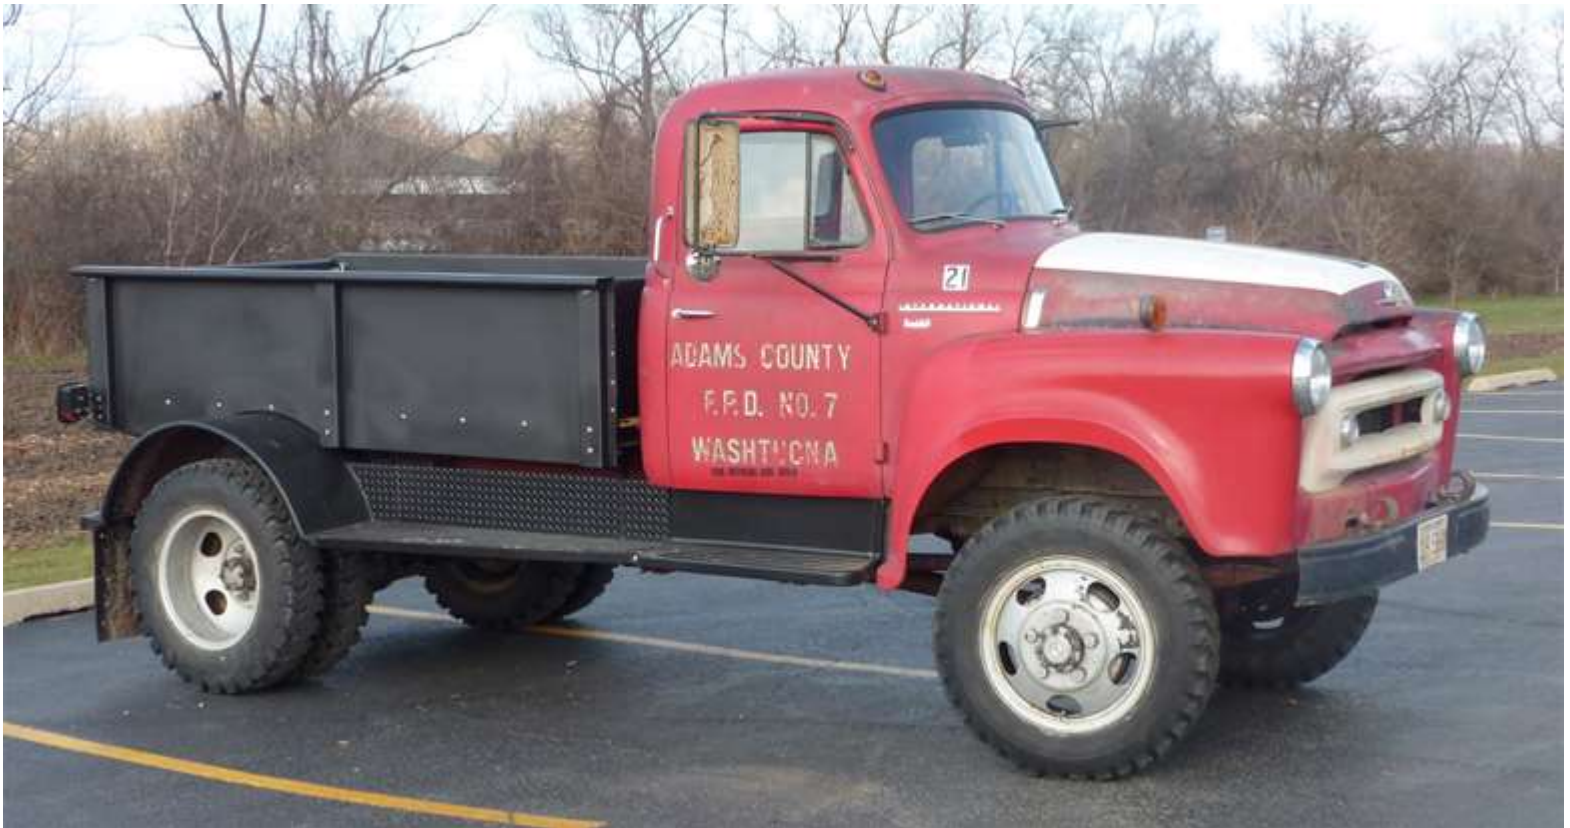
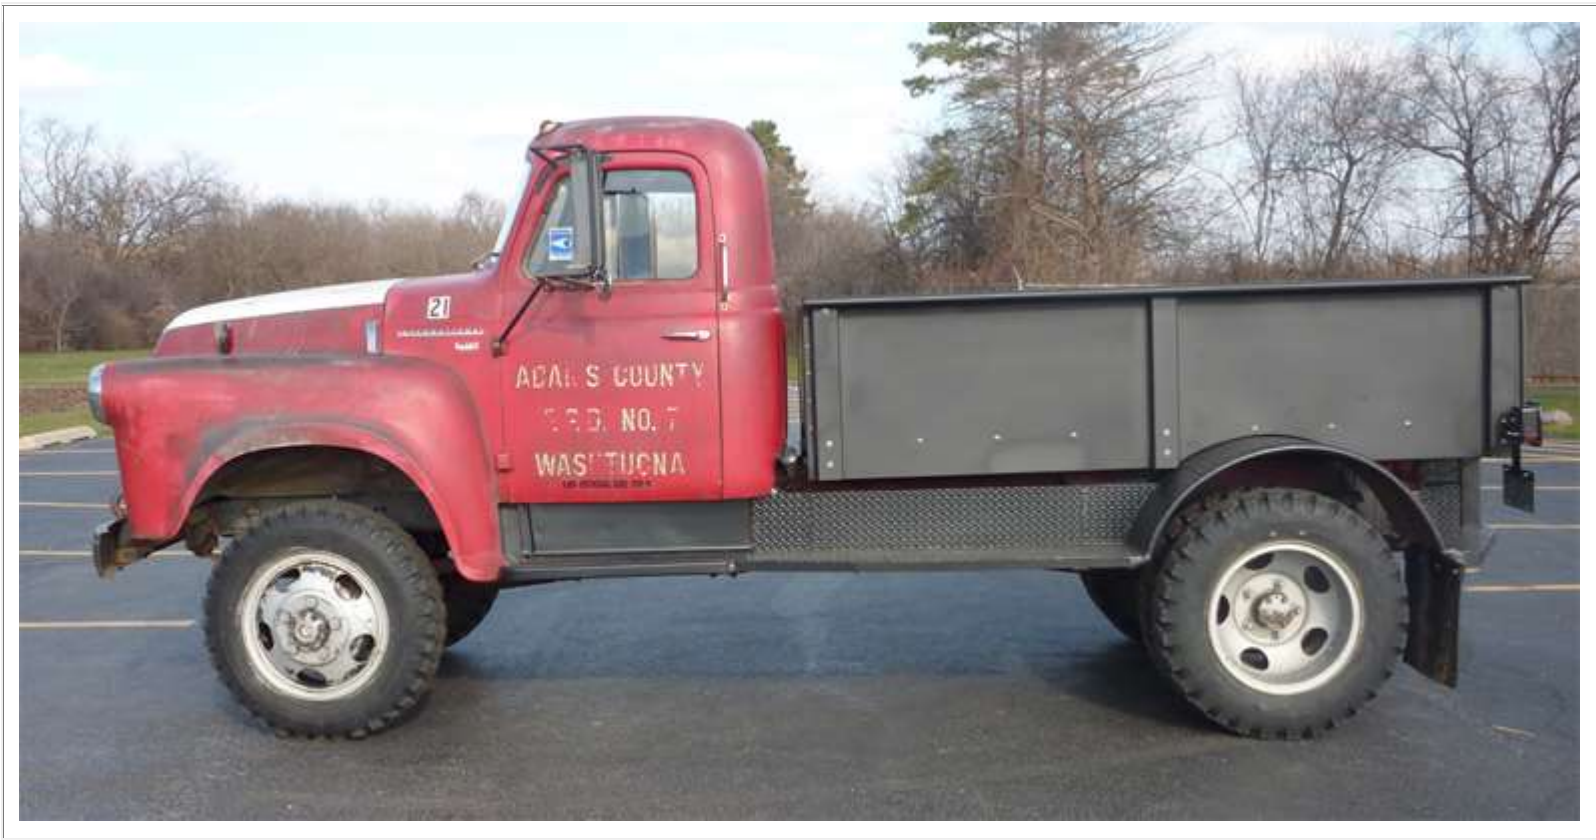
The following photos are of the truck itself. It was a brush fire truck from Adams County, WA and it originally had a rectangular water tank on the back which I replaced with a custom "pickup" box. Although it has surface rust, the truck is rock-solid and free from rot.

The truck is almost 8' high at the roofline. I have about a half-inch of overhead clearance in the garage door opening. I am a little over 6' tall and the hoodline is at eye level. The rims are 20" Budds and the tires are 38" in diameter, so it has plenty of ground clearance.
